Town of Newbury Library

Capital Needs Assessment & Replacement Reserve Analysis

Exterior Envelope & Mechanical Systems

February 7, 2020

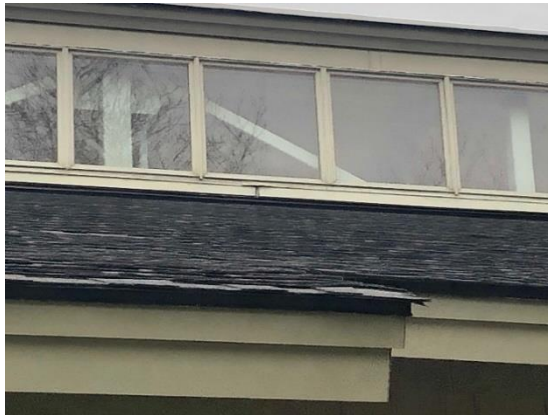
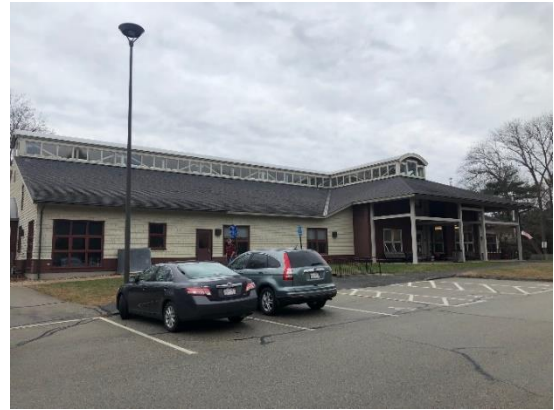
Architectural asphalt shingles cover a majority of the roof and include a ridge vent and exposed copper valley and copper drip edge flashings. The typical life span of an architectural asphalt shingle roof is 30 years. There were numerous examples in which the shingles were cracked and in some cases portions of shingles were missing. All cracked and missing shingles should be replaced immediately. The flashings appear to be in good condition.

The amount of cracked or missing shingles is appropriate for a 19-year old architectural asphalt shingle roof. The report shows costs to repair the roof in year 1. The full replacement of the asphalt shingled roof is shown in year 10, at the end of the roof's lifespan.

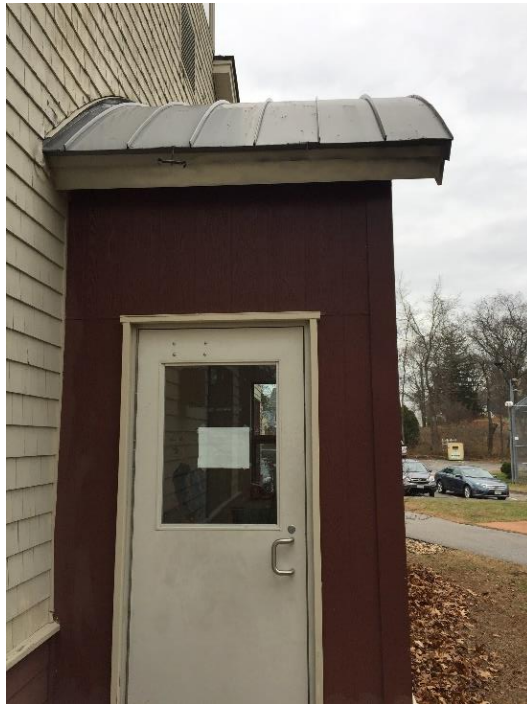
Painted steel standing seam metal roofing covers the main entrance of the library from the parking area as well as the book and audio visual return kiosk on the side of the

building. The roofing has areas in which the finish was damaged and the steel roofing is rusting. These areas are minor and to date all of the corrosion appears to be superficial. However, if allowed to continue the corrosion will spread and will shorten the lifespan of this roofing.

Based on the observed conditions of the standing seam metal roofing, all damaged areas of standing seam metal should be ground down to bare metal, cleaned, primed and painted in year 2. This roofing should be monitored on an annual basis.

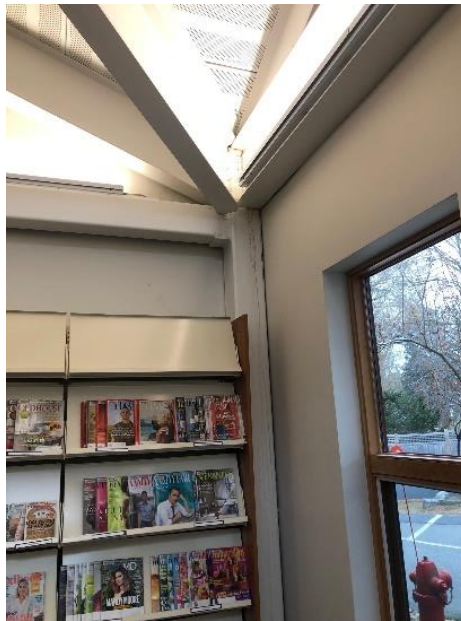
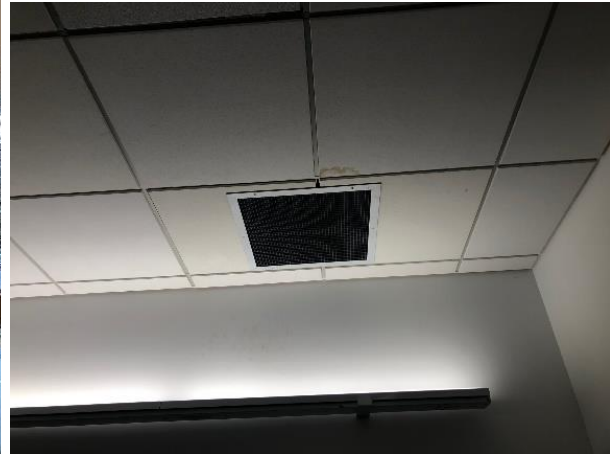
There have been a few roof leaks over the lifespan of the building. While these were all suitably repaired at the time of occurrence, two columns at roof valleys and several ceiling tiles show signs of water damage. Additionally, paint is peeling at several arch-shaped beams at the clerestory.

Repainting of the water-damaged steel and replacement of ceiling tiles at the interior is shown in year 2.

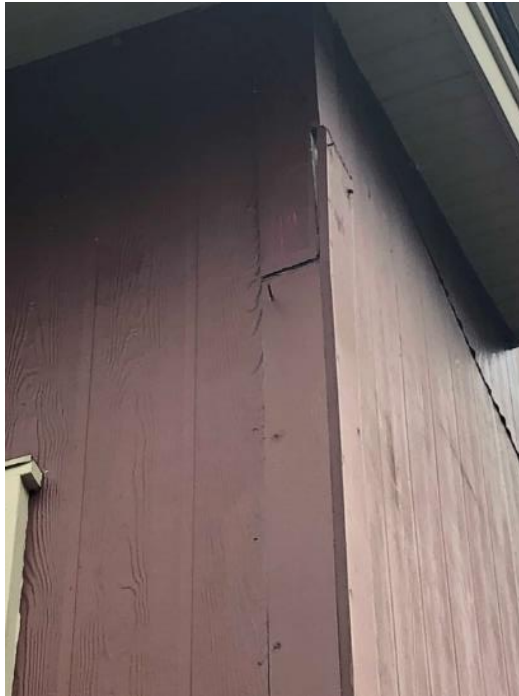
The vertical cementitious siding is located at three locations. The siding appears to be in good condition and should last the lifetime of the building with proper maintenance. Cementitious siding throughout is degrading at the ground level, and needs approximately 12% replacement.

Repair of cementitious siding is shown in year 1. Repair of all siding should occur before the full exterior repainting shown in year 3.

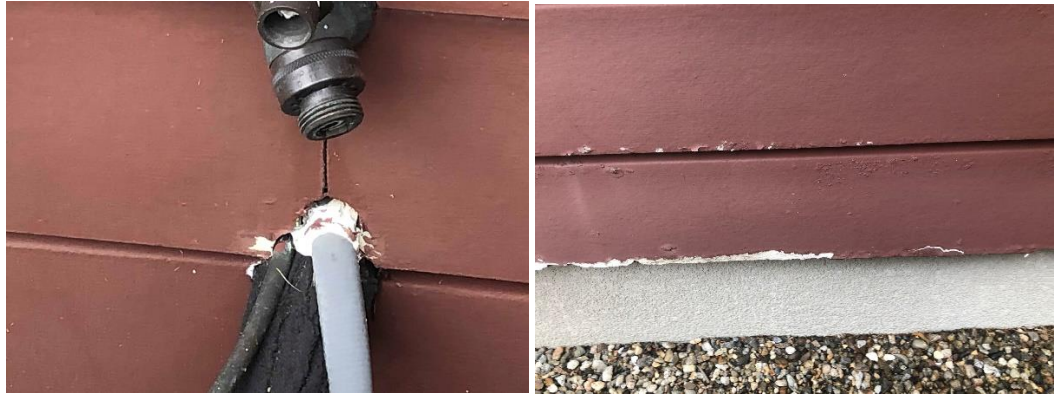
Horizontal Cementitious siding is located around the perimeter of the building, from the top of the foundation wall to the bottom of the water table trim. As above, the siding is degraded at ground level, and needs repair and replacement at approximately 12%. Several locations around the building need trim repair, as well as sealing around wall penetrations. In locations where siding is within 4" of the slab or finish grade, the repair should include raising the lower edge to manufacturer's recommendation.

Repair of the cementitious trim and siding is shown in year 1, prior to full exterior repainting in year 3.

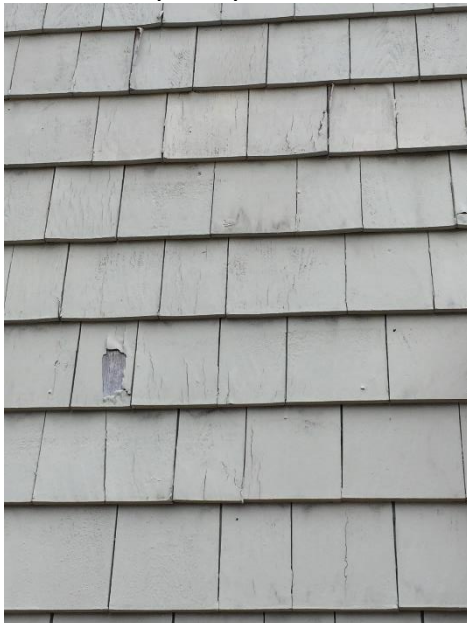
Cedar shingles cover the majority of the library and appear to have a colored stain finish. They are observed to be in good condition , with the finish showing signs of sun and damage.

Surface preparation and repair of the cedar shingle siding is shown in year 1, prior to full exterior painting in year 3. Regular repair of the cedar shingles is shown every five years.

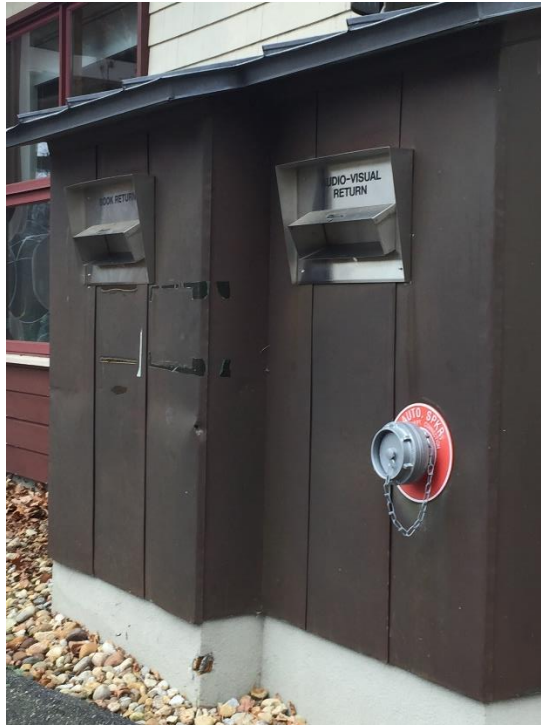
The existing book/audio visual return kiosk, which also houses a fire department connection, is clad in copper siding. This enclosure has several dents and holes in

the metal siding, likely from snow plowing. Otherwise the cladding is in good condition and does not require any work at this time.

Repair of the metal siding is shown in year 2. The projected lifecycle of the copper siding is 40+ years and would not need replacing during the course of this CNA.

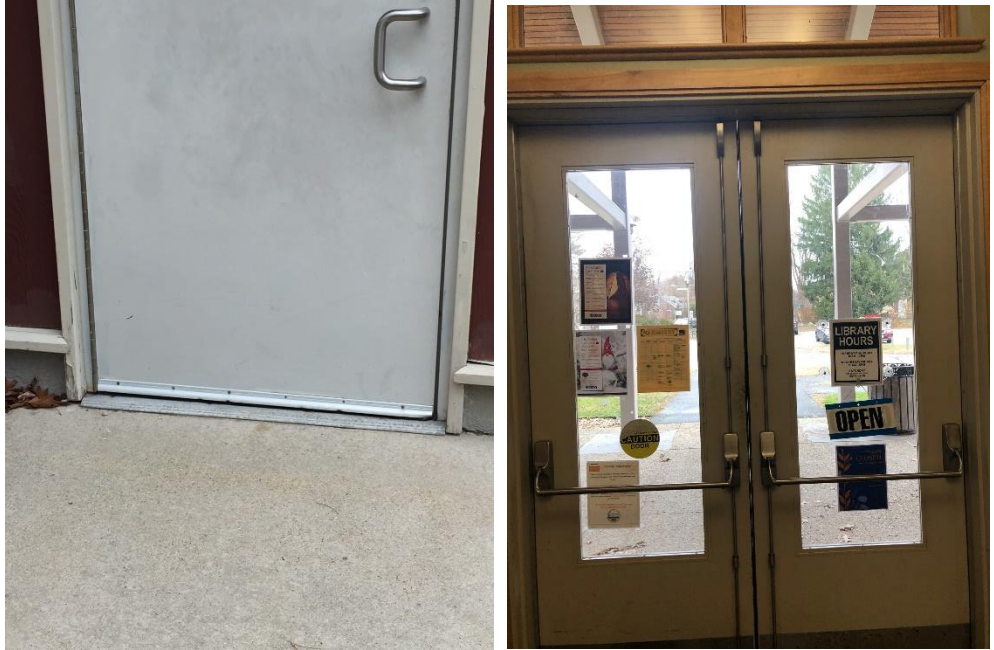
The main entrance, secondary handicapped entrance, and maintenance storage entrance, all have aluminum and glass storefront-style entry systems. They are original to the building and are in good condition. No operational problems with the doors were observed or reported at the time of the inspection, so no work is needed at this time. The door sweeps are aging and are no longer functional.

Future, in-kind, replacement of the entry doors systems is shown in year 18, after 30 years of service. New sweeps at all exterior doors are shown in year 2. Any interim repair and maintenance needs should be addressed from the operating account.

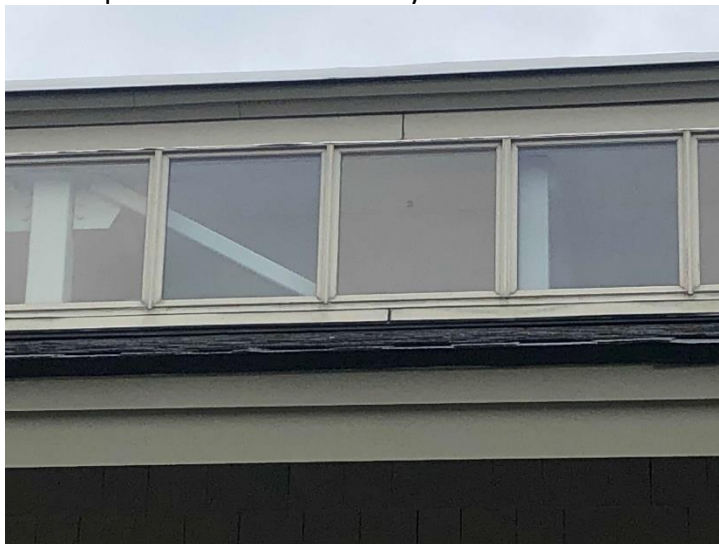
An atrium space is created along the axes of the building with clerestory windows. The windows are fixed, double glazed, wood with aluminum exterior cladding and most appear to be in satisfactory condition. Within the first five years of the building, flashing was repaired due to leaking, and the solution has been sufficient. The lifespan of these windows is projected to be 30 years and they are original to the building. New caulking and sealant of all windows is shown in year 4.

Future replacement of the aluminum clad windows is shown in year 14, after their expected useful life of 30 years.

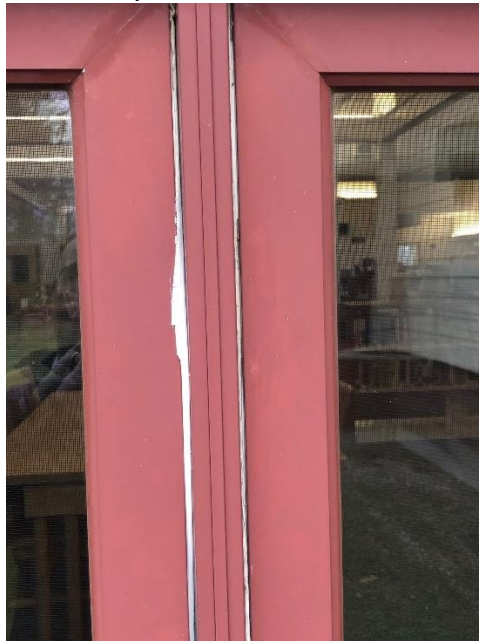
The first floor windows are all fixed and operable, double glazed, wood with aluminum exterior cladding and appear to be in satisfactory condition. Several locations have damaged seals, gaskets, or screens. The lifespan of these windows is projected to be 30 years and they are original to the building.

Future replacement of the aluminum clad windows is shown in year 17, after their expected useful life of 30 years. New caulking and sealant of all windows is shown in year 4.

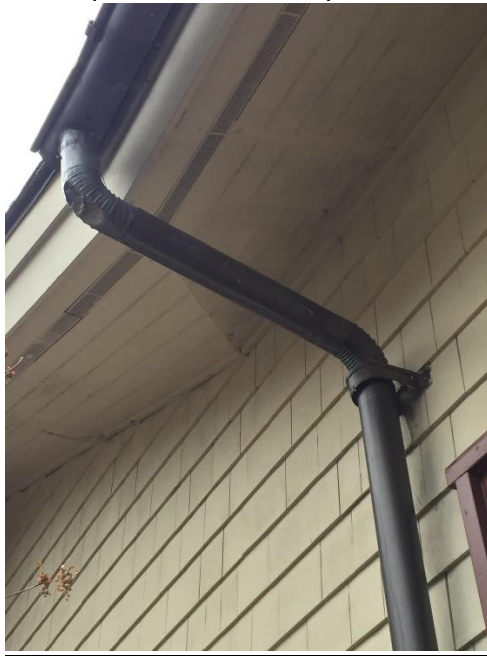
Most of the water draining from the roof of the library drains directly onto a pea-stone areaway that runs along the perimeter of the building. In a few locations, copper gutters and downspouts are present, mainly at entries to the building, and are original to the building. They appear to be in good condition and no work is required at this time. Very few locations have the downspout loosened from the clips or other superficial damage. In addition to these locations, the entire building at the gutters, soffits, and interior corners, needs cleaning of wind-blown debris, mildew and insect traces.

The projected lifecycle of the new copper gutters and downspouts is 70+ years and would not need replacing during the course of this CNA. Minor repair of the downspouts is shown in year 1.

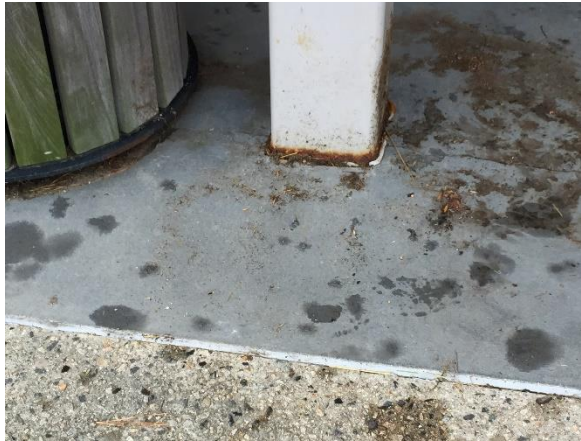
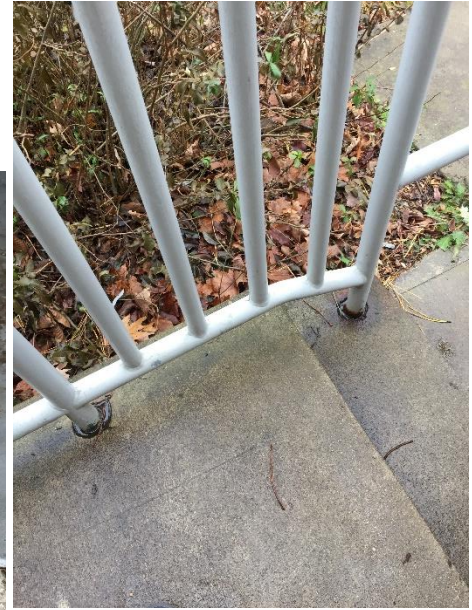
The framing at the front, covered entry is painted tube steel. The steel is in good condition and is expected to have a lifespan of over 100 years. Humidity and proximity to the ocean has caused the paint on the steel to peel and rust in some locations. Additionally, the grout at the column bases is degraded and missing, allowing water to pool and damage the column. Similar damage can be seen at the rear entry, where a handrail meets a concrete step.

The cost of sanding and priming & painting of the steel beams and columns is included in year 1. Also included is regrouting the column and rail bases. Subsequent sanding and repainting will be included in years 10 & 20.

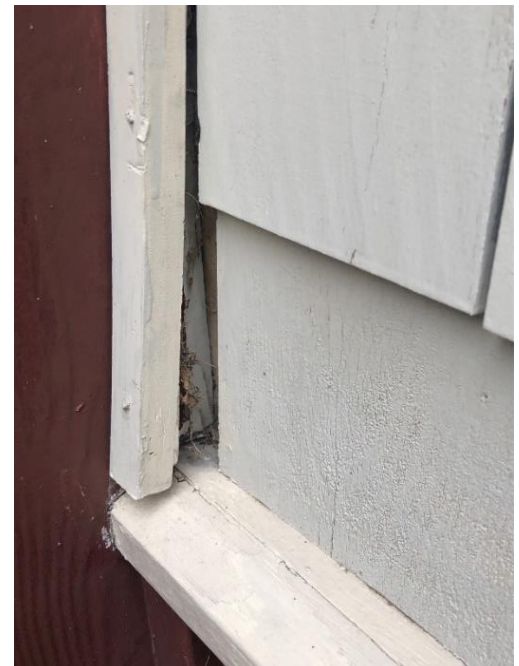
Some areas of the horizontal cementitious siding and the wood trim have gaps that may allow for water infiltration. There are also locations at the clerestory windows where gaps have formed and separated at the existing sealant. It appears that even with previous repairs, separation has occurred between materials.

The cost of removing and replacing failed sealant of approximately 50+ linear feet is included in year 1. Subsequent maintenance of the caulking and sealant will be included in years 10, & 20 of the worksheet.

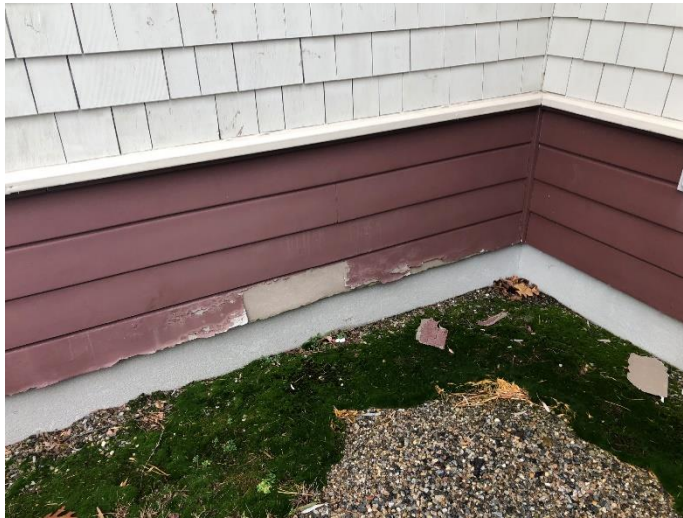
Much of the siding base, whatever the material, is degraded at the ground level. Areas of heavy damage are near downspouts, or where roof valleys exist with no gutters and downspouts. While repair of the damaged materials is shown elsewhere, the entire perimeter needs to be cleaned of built-up debris, grade lowered in some areas, and pea stone placed at problem areas to aide in drainage.

The cost of clearing debris, regrading problem areas, and installing 4 yards of pea stone is included in year 1. Routine maintenance and cleaning of the building perimeter should be part of the operations budget.

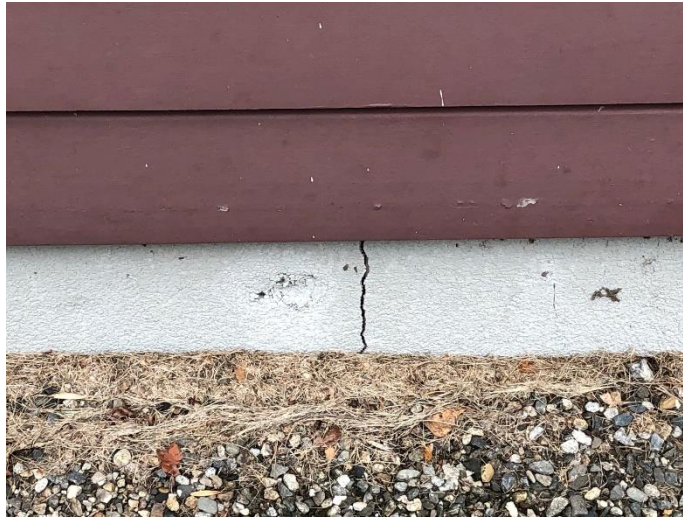
The exterior of the concrete foundation wall of the library is covered with E.I.F.S. (exterior insulation finish system) and has varying exposures, some locations have 8" from grade to the wood siding and others have over 12". Select areas show damage at corners, some cracking, including at the book drop off area.

The cost of repairing the E.I.F.S. is included in year 1. The cost of repainting the EIFS is included in the full building repainting in year 3. Regular maintenance is included in

years 12 & 20. This maintenance cycle would include cleaning, caulking, and painting to extend the life of the finish. If properly cared for, E.I.F.S. should last more than 50 years.

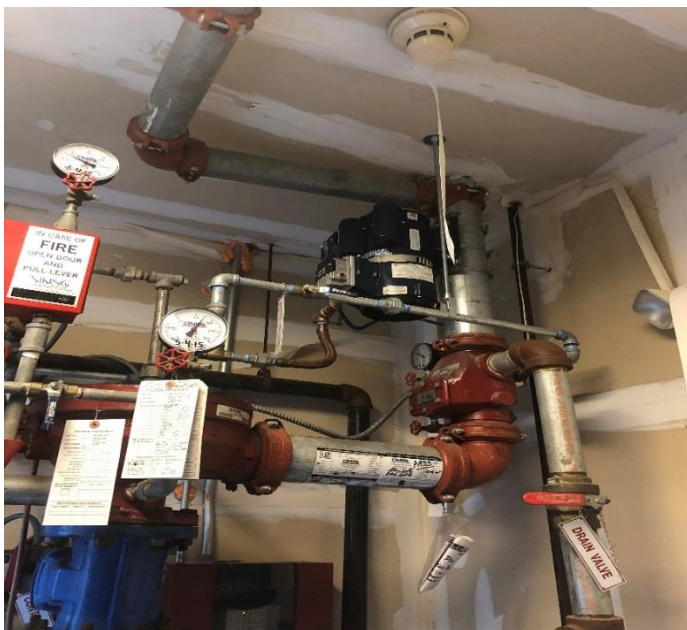
Figure 3: Pre-Action Valve and Controls within the sprinkler room

The existing pre-action system valve, trim, controls and panel will need to be replaced in 10 – 15 years.

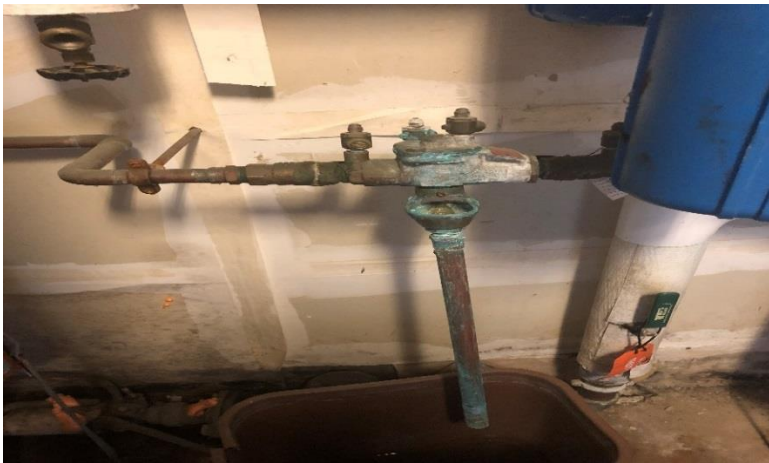
Exception: The existing reduced pressure backflow preventer located on the make-up water to the HVAC boiler is showing signs of corrosion. This device should be tested to verify proper function. This device should be replaced within the next 3 years.

Figure 2: Reduced pressure backflow preventer for the HVAC boiler make-up water

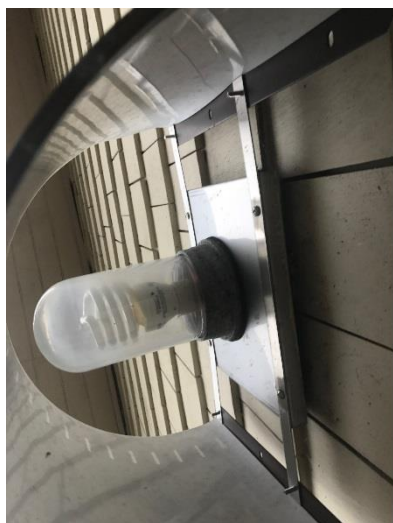
Figure 24: Exterior Wall-Mounted Sconce

The fixtures should be replaced in the next 3 to 5 years. The wall packs should be replaced with new fixtures that contain LED lamps/modules and have an emergency component to them. This emergency component is necessary to meet the International Building Code (IBC Section 1006) for Emergency Illumination for Egresses.

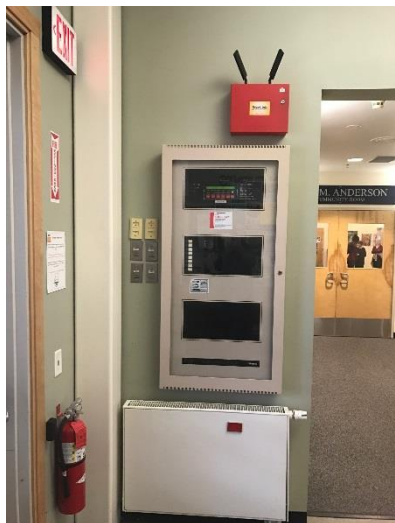
The system has reached its expected life expectancy. Fire Alarm devices tend to require replacement at 10-12 years and control panels at 20 years.

Figure 30: Simplex 4100 Voice Evacuation FACP

The entire fire alarm system (including FACP, devices and wiring) should be replaced within the next 2-3 years. The existing Digital Communicator, recessed Masterbox and Knox Box could be retained. The new devices would replace the existing devices (one for one), as the existing devices and locations are adequate and meet present building and fire alarm codes.
