Town of Newbury Library

Capital Needs Assessment & Replacement Reserve Analysis

Exterior Envelope & Mechanical Systems

February 7, 2020

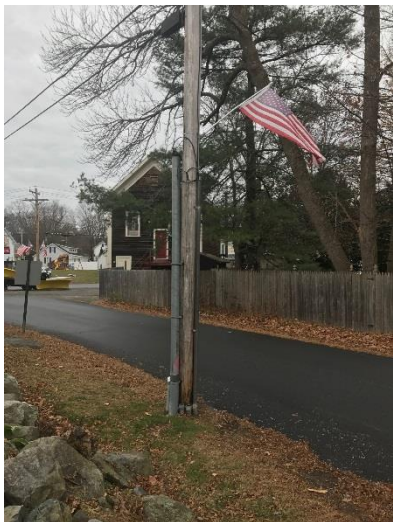
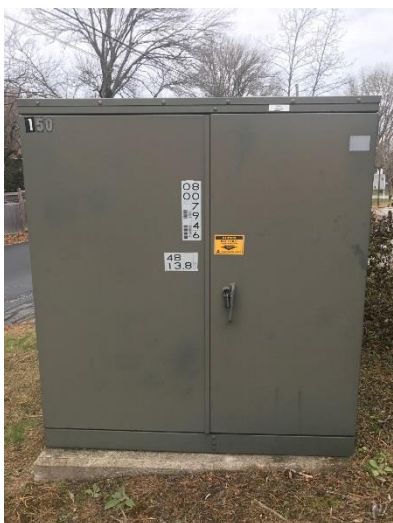
The existing service originates from a National Grid utility pole (1-4" conduit) to a 150 KVA, 13.8 KV primary /208 volt 3-phase pad mounted utility-owned transformer. (Figures 1, 2) The services has one meter, located on the building exterior. (Figure 3) The incoming service is fed underground via (4) 3" conduits and terminates in a 600 amp, 208 volt, 3-phase enclosed circuit breaker. The enclosed circuit breaker was manufactured by Siemens, is from the original construction (2000) and appears to be in good working condition.

Figure 1: 13.8 KV Primary Feeder

Figure 2: 150 KVA, 13.8 KV/208V 3-Phase NGRID Transformer

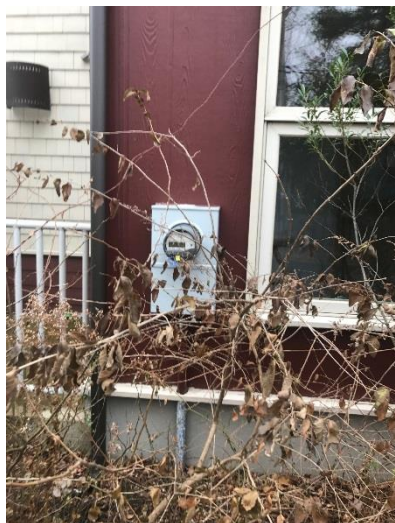
Figure 3: Library Electric Meter

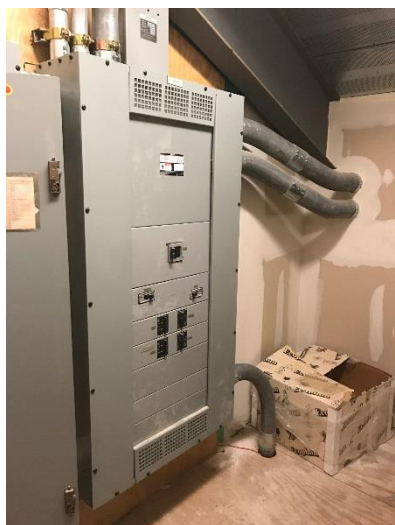
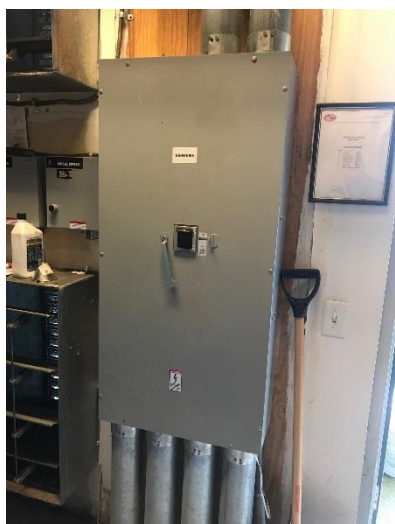
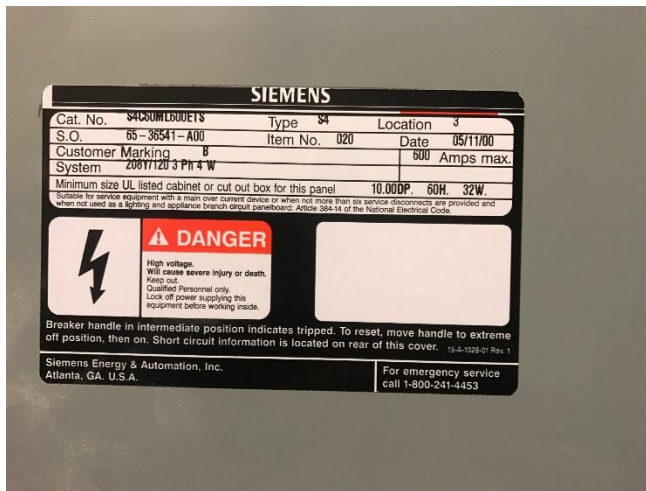
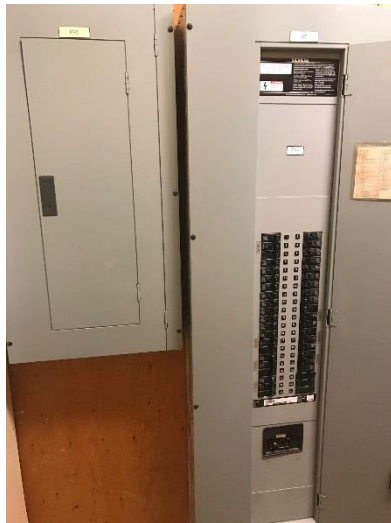
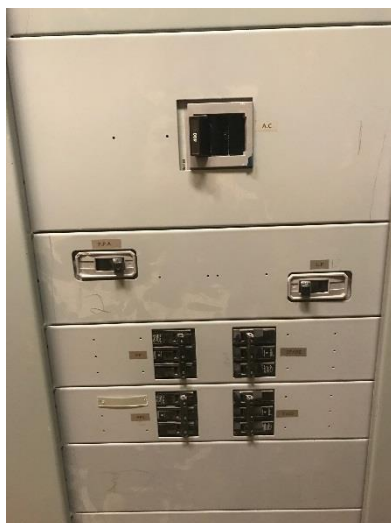
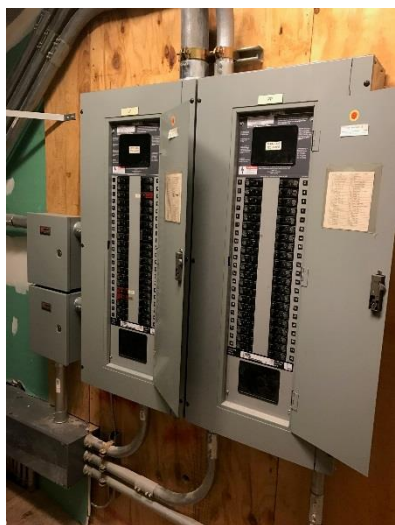
Figure 4: 600 Amp, 208 Volt Main Switchboard - Mezzanine

Figure 5: 600 Amp, 208 Volt 3-Pole Service Entrance Disconnect

Figure 6: Main Service Switchboard Nameplate

Figure 7: Typical 120/208V 3-Phase, 4-Wire Panelboards

Figure 8: Main Switchboard – Panel Feeder Breakers

Figure 9: Typical Lighting & Power Panelboards

The service switchgear has a remaining 15 years of expected lifespan. The switchgear should be cleaned, tested, re-torqued to manufacturer's recommendations and infra-red tested.

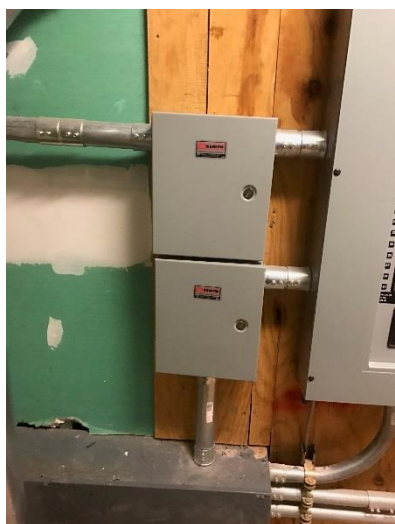
The building's lighting controls consists of (2) Zenith lighting contactors. These contactors control the exterior site lighting as well as the library main lighting. Individual offices and bathrooms contain occupancy wall-mounted sensors. The controls appear to be in good working condition and have an additional 5-7 years of useful life.

Figure 11: Lighting Controls

Replace occupancy sensors within the next 3-5 years prior to failure. The town should consider adding day-light sensors for control of fixtures directly below the sky-lights, for added energy savings.

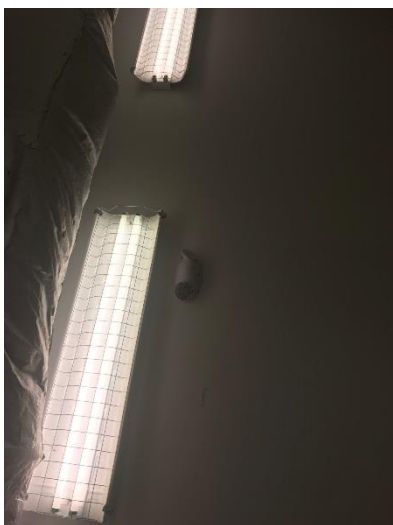
Figure 13: Typical Fluorescent Fixture and Emergency Light

The emergency batteries within the lighting units have most likely been replaced already. The town should continue to test the fixtures on an annual basis and replace the batteries on an as-needed basis.

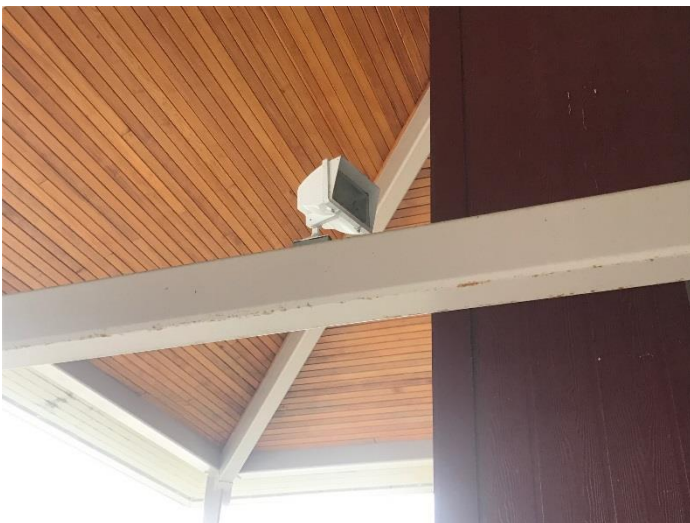
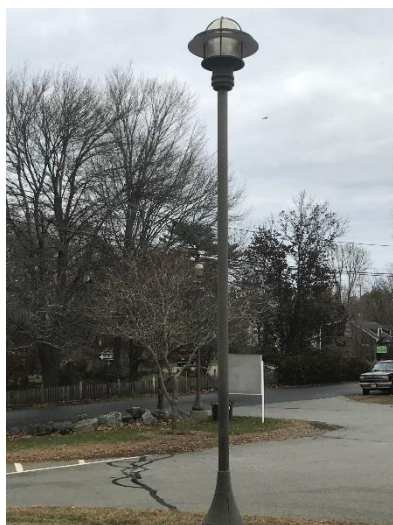
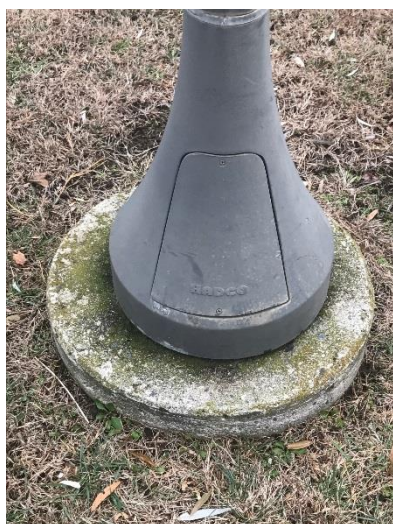
Figure 21: Front Entrance Floodlight

Figure 22: Typical Site Pole Light

Figure 23: Typical Pole-Base

The fixtures should be replaced in the next 3 to 5 years. The wall packs should be replaced with new fixtures that contain LED lamps/modules and have an emergency component to them. This emergency component is necessary to meet the International Building Code (IBC Section 1006) for Emergency Illumination for Egresses.

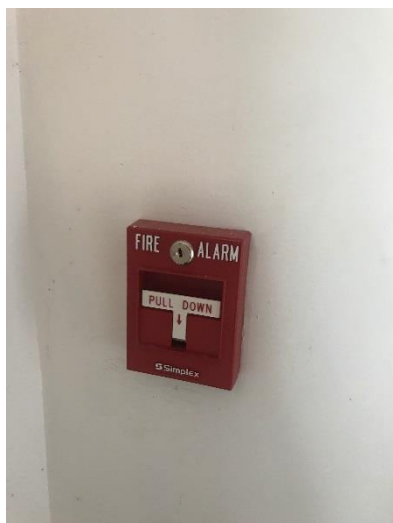
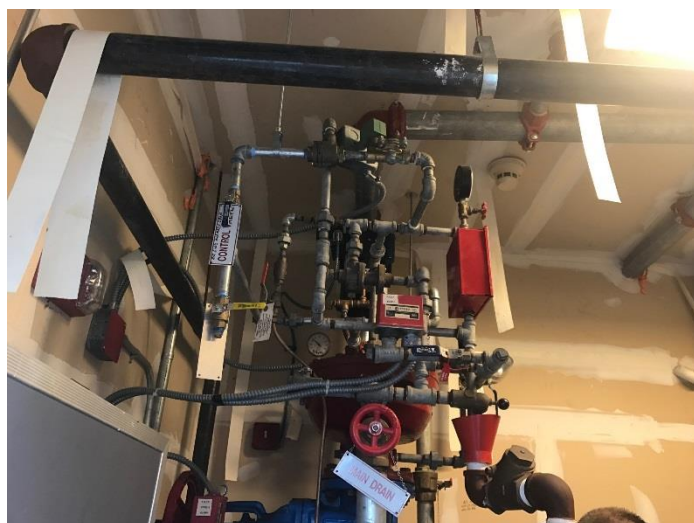
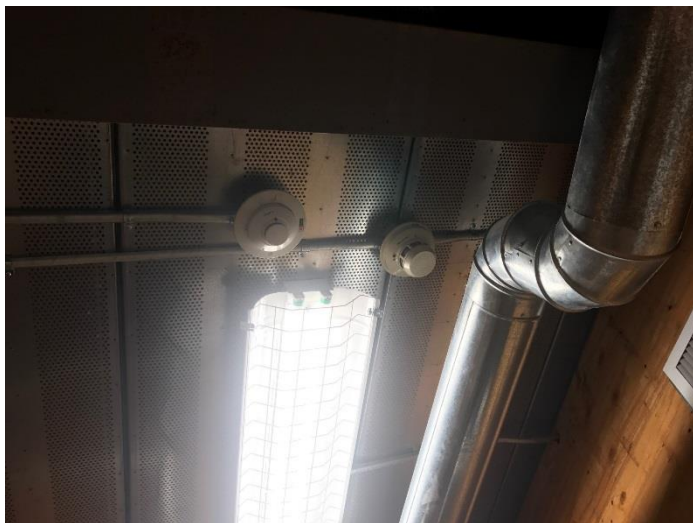
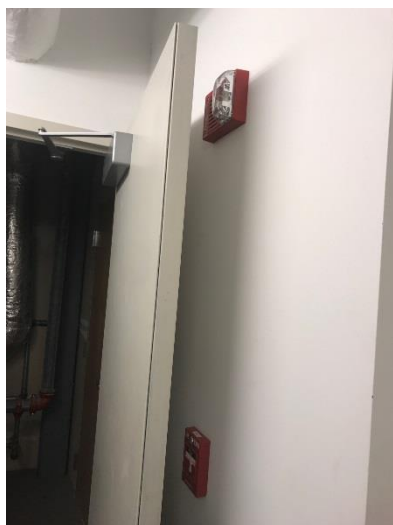
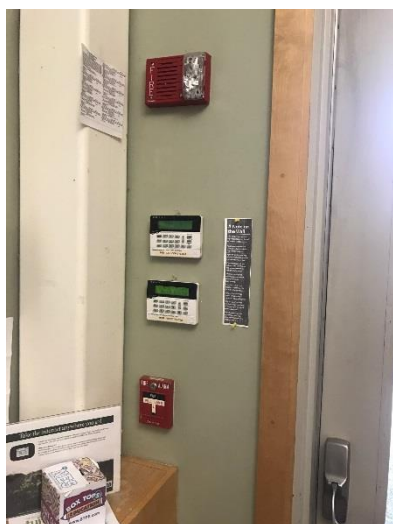
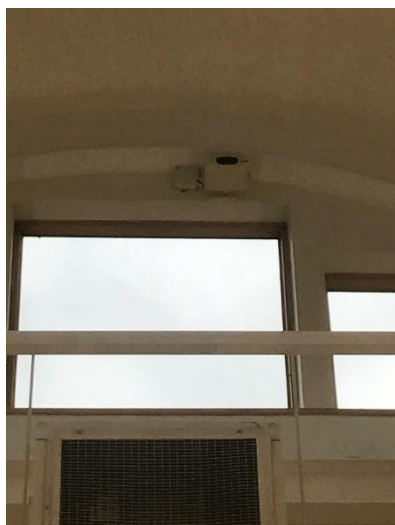
The system has reached its expected life expectancy. Fire Alarm devices tend to require replacement at 10-12 years and control panels at 20 years.

Figure 25: Typical Fire Alarm Manual Pull Station

Figure 26: Main Service Entrance Sprinkler Room Fire Alarm Devices

Figure 27: Typical Fluorescent Fixtures, Smoke and Heat Detector

Figure 28: Typical Manual Pull Station & Speaker/Strobe

Figure 29: Main Pull Station and Speaker/Strobe

Figure 31: Beam Smoke Detector

The entire fire alarm system (including FACP, devices and wiring) should be replaced within the next 2-3 years. The existing Digital Communicator, recessed Masterbox and Knox Box could be retained. The new devices would replace the existing devices (one for one), as the existing devices and locations are adequate and meet present building and fire alarm codes.
